# Habitat restoration monitoring update

# New Forest Freshwater and Wetland Restoration Plan

## Key principles of freshwater and wetland restoration monitoring in the New Forest

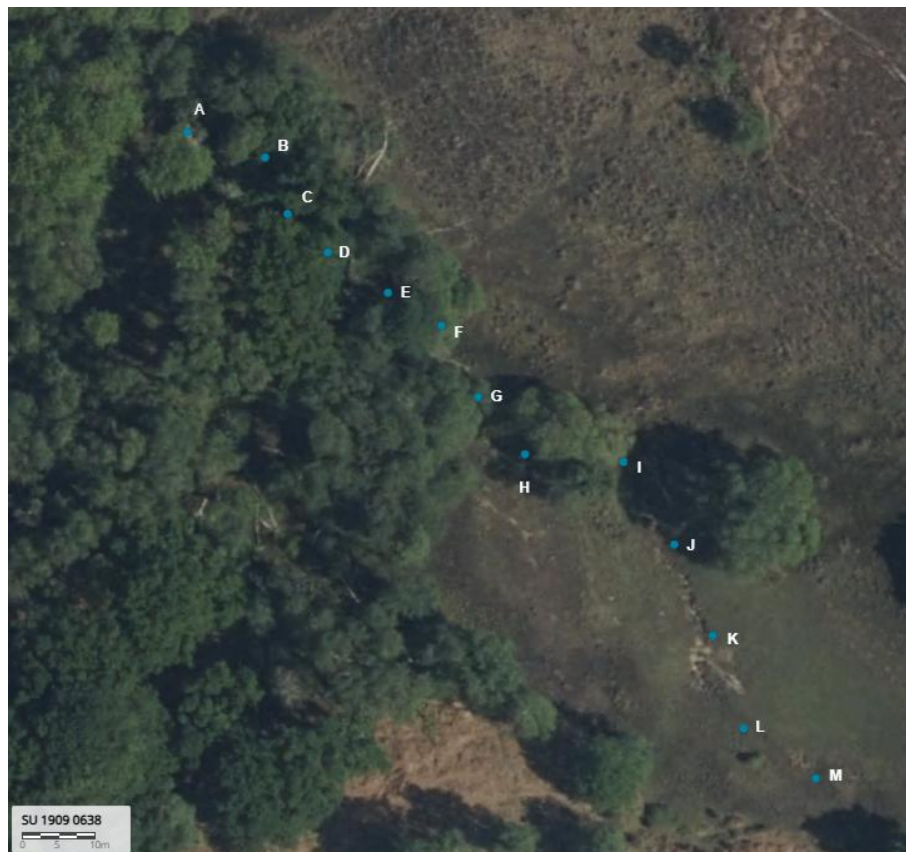
# Picket Mire – Physical features

Channel dimensions

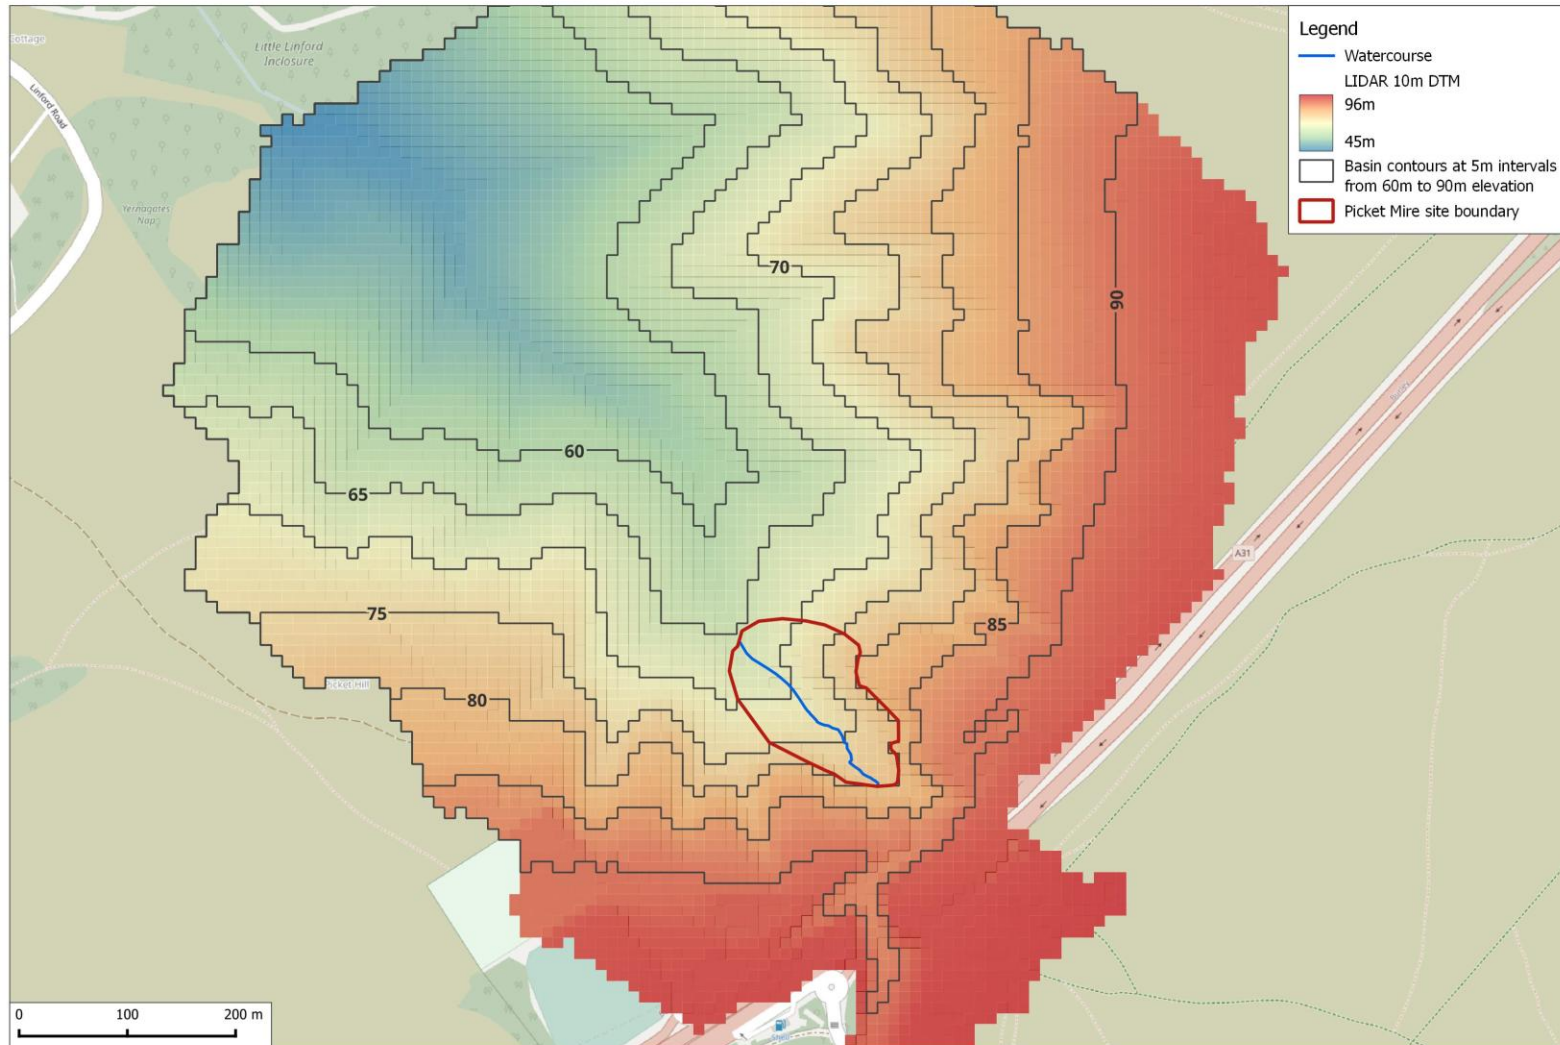
Map 3: Height data used to identify a site boundary for Picket Mire
